QUEEN KAAHUMANU HIGHWAY, WIDENING, PHASE II KEALAKEHE PARKWAY TO KEAHOLE AIRPORT ACCESS ROAD PROJECT NO. NH-019-1(38)R

CLOSEOUT MEMO

Subject: End of Fieldwork Letter for Data Recovery for the Proposed Queen Ka'ahumanu Highway Widening Phase 2 Project, Kalaoa, Kalaoa-'O'oma, 'O'oma 2, Kohanaiki, Kaloko, Honokōhau 1-2 and Kealakehe, North Kona District, Hawai'i Island, TMK: [3] 7-4-008, 7-3-009 and 7-3-043 submitted for review

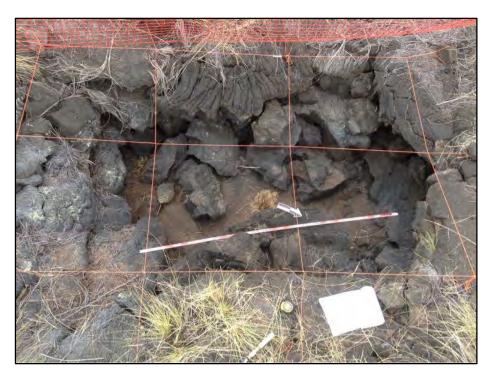
Several historic properties called for 100% aerial excavation. At these sites, a grid pattern was established with 1 m between grid lines; each 1 by 1 m section was then documented as an individual test unit (example provided in Figure 5). The locations of data recovery test units were accurately depicted on all site plan maps and documented using sub-meter accurate Trimble GPS. Test units were hand excavated under controlled conditions using trowel and brush (no shovels). A 1 by 1-m or 0.5 by 1.5 m test unit location was established using string and datum nails. A preexcavation photograph was taken and a surface sediment sample for potential pollen analysis was collected where applicable. Excavation was completed by 10 cm levels within discrete stratigraphic layers to bedrock. Sediment from each strata or arbitrary level was screened separately, and all cultural material was collected and bagged by provenience. Test unit documentation included a plan view map of the surface at each stratigraphic level and at the base of excavation of each unit, as well as stratigraphic profile maps of two perpendicular excavation sidewalls. A radiocarbon sample was collected from the surface and base of excavation in each test unit. A sediment sample was collected from the surface and base of excavation in applicable test units for potential pollen analysis. All charcoal or carbonized plant material was collected separately in sterile aluminum foil packets and bagged by provenience for wood taxa identification and potential radiocarbon analysis. Following excavation and sampling, post-excavation photographs were taken and the test units were backfilled. The archaeological sites and/or features subjected to subsurface testing were restored as best as possible to their original condition.

Figure 5. Photograph showing an example of aerial excavation (at SIHP # -28813-B) using a 1 by 1 m grid; view to west

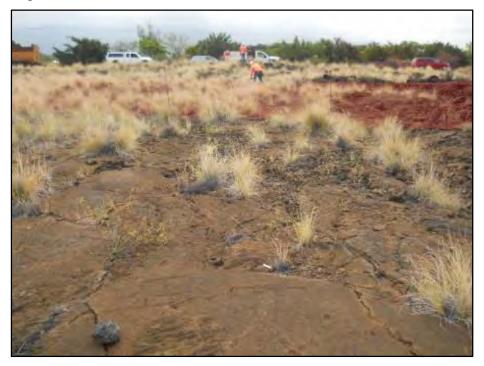
Figure 6. Photograph showing installation of orange barricade fencing for interim protection mitigation at SIHP # - 19945 Features A and B (visible in left forground); view to east

with Queen Ka'ahumanu Hwy. in the background

All historic properties to be preserved (including trail sites) have been clearly identified on the ground with weather-resistant metal tags providing the SIHP site number and the preservation status. Interim preservation measures to protect the historic properties north of the northern limit of <u>Kaloko-Honokōhau</u> National Historical Park consist of orange barricade fencing tied to steel posts erected at each site in accord with the graphical depictions in the site-specific presentations in the data recovery and preservation plan (Shideler et al. 2012) and preservation and mitigation plan (Hammatt and Shideler 2014)

For the historic properties along the highway construction limits from the southern end of Kaloko-Honokōhau National Historical Park to its northern end, which equals a distance of approximately 7,989 ft (2435 m) or 1.51 statute miles, the interim protection measure on the ground consists of a continuous line of orange barricade fencing supported by steel posts along the precise road construction limits

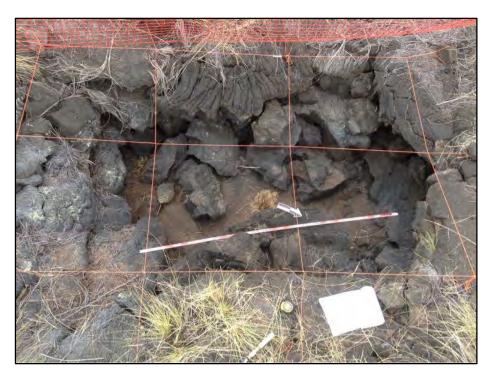
Several historic properties called for 100% aerial excavation. At these sites, a grid pattern was established with 1 m between grid lines; each 1 by 1 m section was then documented as an individual test unit (example provided in Figure 5). The locations of data recovery test units were accurately depicted on all site plan maps and documented using sub-meter accurate Trimble GPS. Test units were hand excavated under controlled conditions using trowel and brush (no shovels). A 1 by 1-m or 0.5 by 1.5 m test unit location was established using string and datum nails. A preexcavation photograph was taken and a surface sediment sample for potential pollen analysis was collected where applicable. Excavation was completed by 10 cm levels within discrete stratigraphic layers to bedrock. Sediment from each strata or arbitrary level was screened separately, and all cultural material was collected and bagged by provenience. Test unit documentation included a plan view map of the surface at each stratigraphic level and at the base of excavation of each unit, as well as stratigraphic profile maps of two perpendicular excavation sidewalls. A radiocarbon sample was collected from the surface and base of excavation in each test unit. A sediment sample was collected from the surface and base of excavation in applicable test units for potential pollen analysis. All charcoal or carbonized plant material was collected separately in sterile aluminum foil packets and bagged by provenience for wood taxa identification and potential radiocarbon analysis. Following excavation and sampling, post-excavation photographs were taken and the test units were backfilled. The archaeological sites and/or features subjected to subsurface testing were restored as best as possible to their original condition.

Figure 5. Photograph showing an example of aerial excavation (at SIHP # -28813-B) using a 1 by 1 m grid; view to west

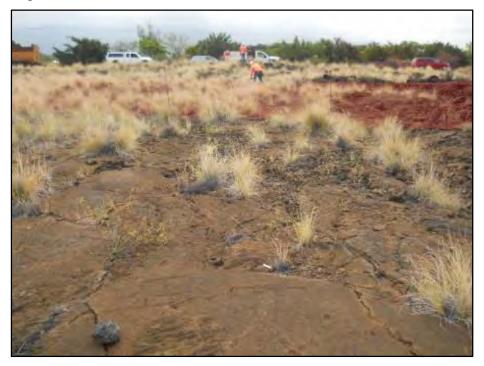
Figure 6. Photograph showing installation of orange barricade fencing for interim protection mitigation at SIHP # - 19945 Features A and B (visible in left forground); view to east

with Queen Ka'ahumanu Hwy. in the background
